## PROJECT SCOPING REPORT

**P.I.N. 328717**

Highway Safety Project  
Route 370 (Onondaga Lake Parkway),  
Old Liverpool Rd. to I81  
Town of Salina, Village of Liverpool  
Onondaga County

Route 370 (Onondaga Lake Parkway) Safety Improvements

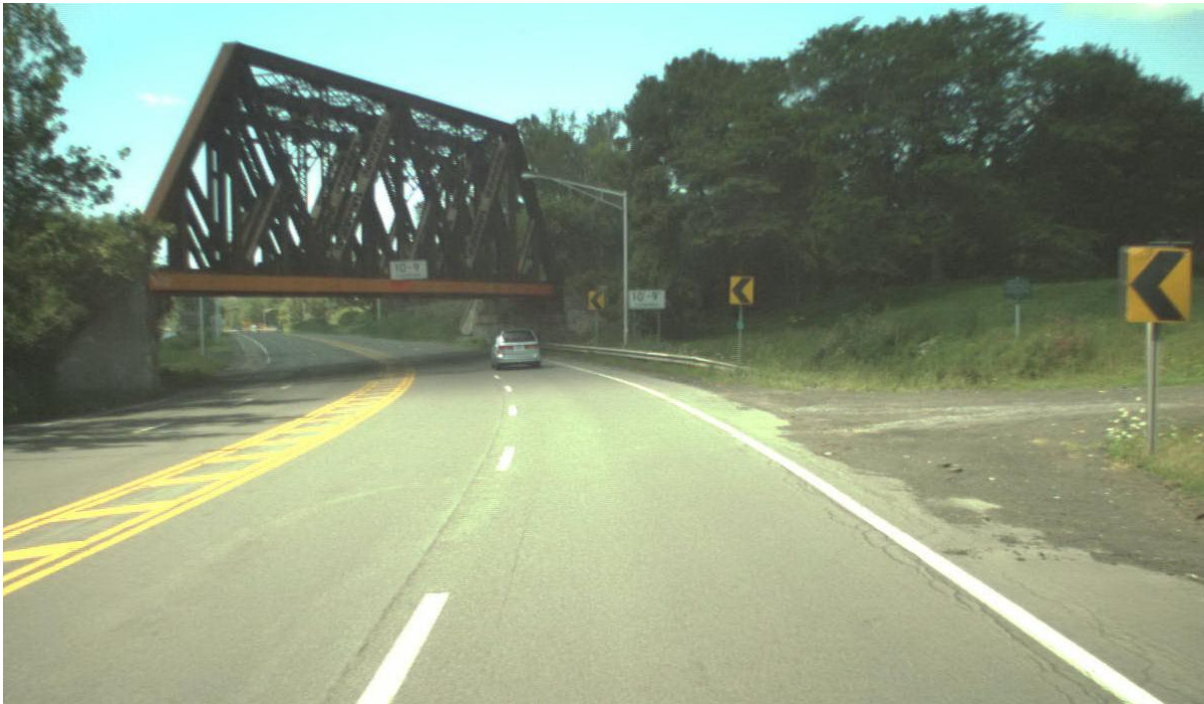
CSX Railroad Bridge over highway, heading westbound. Note minimal horizontal clearance and posted 10' 9" vertical clearance at railroad bridge.

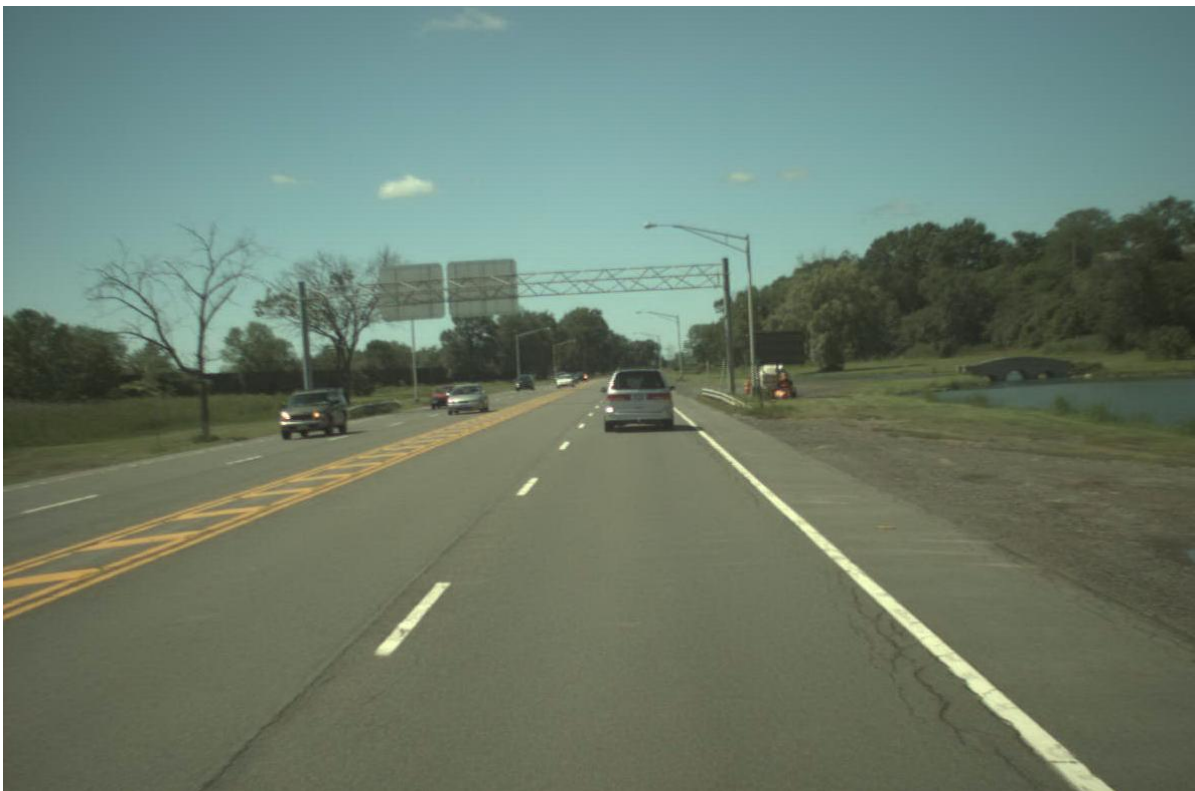
Typical section, westbound. Note Wedding Bridge on right.

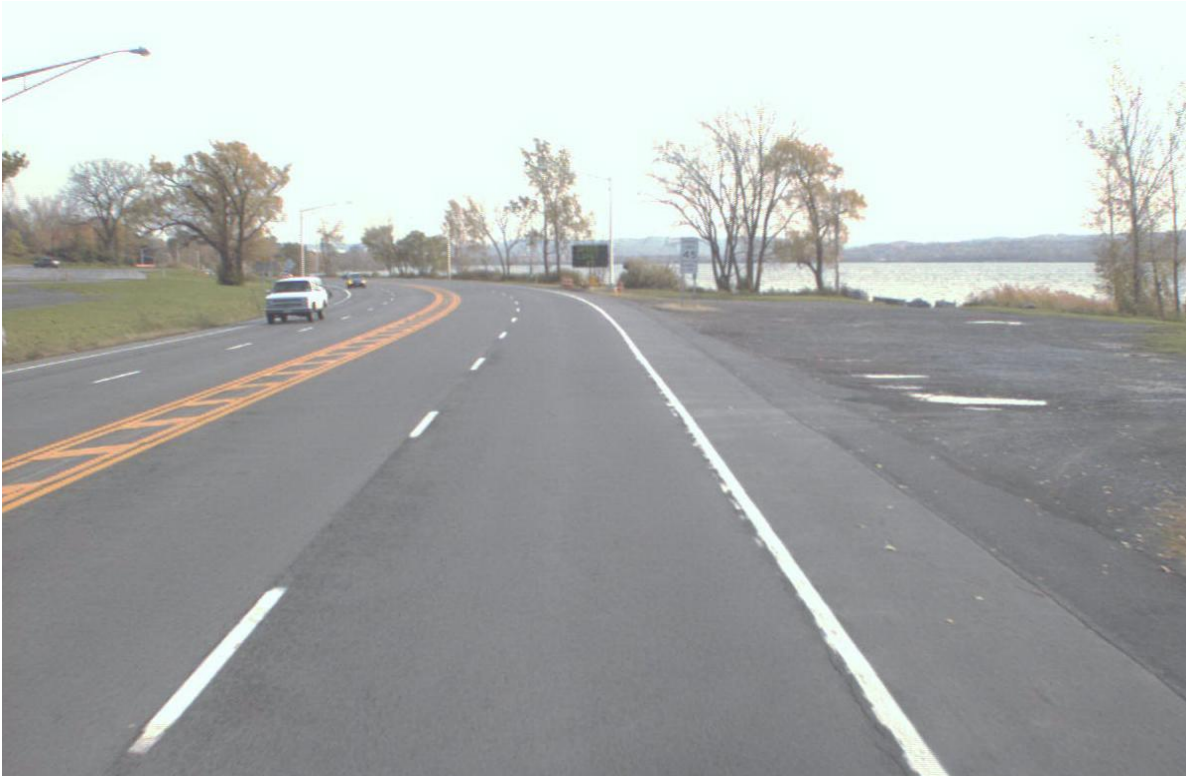
Typical section, eastbound. Note parking area with undefined access on right side

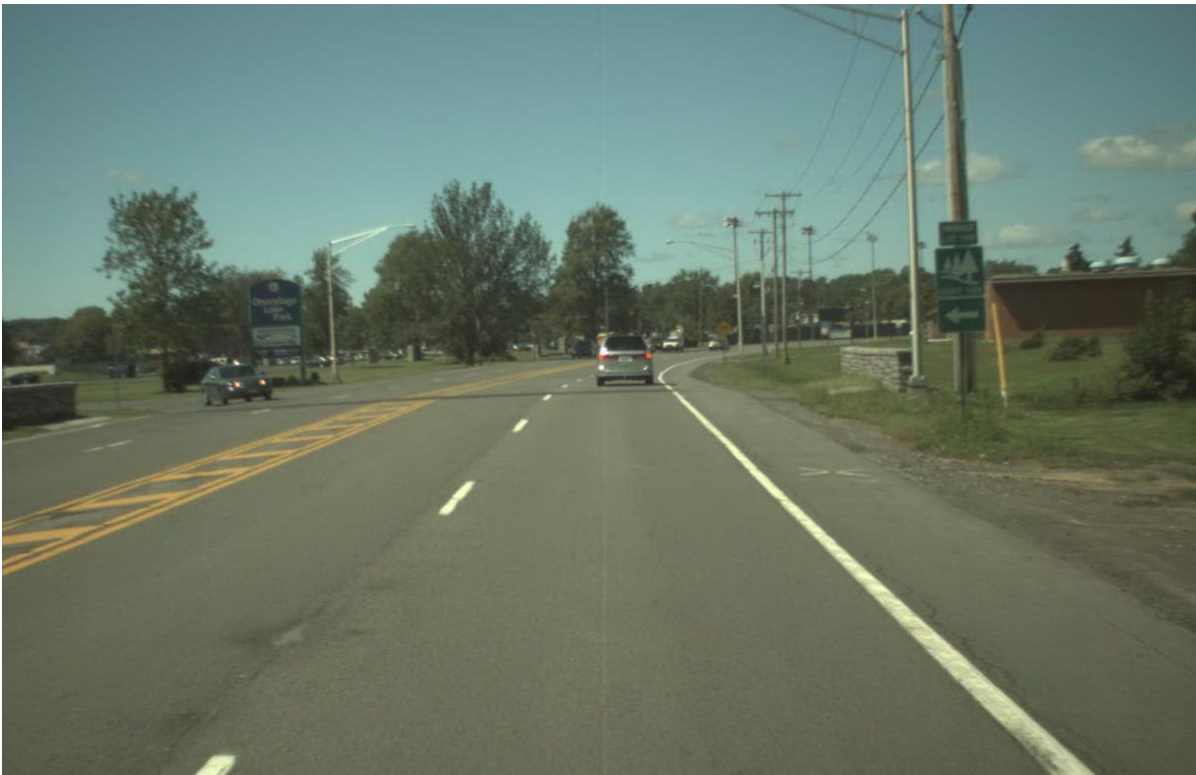
Highway near Onondaga Lake Park Entrance, heading westbound towards Village of Liverpool. Note stone barrier walls of Bloody Brook culvert

The culvert over Bloody Brook has nonconforming barrier. The existing barrier is a deteriorating stone wall built in 1932 and is National Register of Historic Places-Eligible. This wall also represents a fixed object hazard. The culvert itself is in fair to good condition overall, with a general, structural and channel recommendation of 5 and a barrel rating of 4. Further assessment of its condition, hydraulics and determination of whether or not it will be retained will be done during the project design phase.

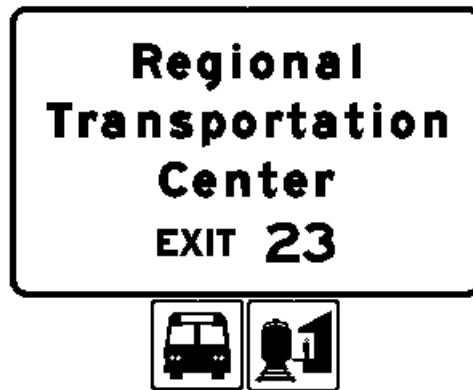
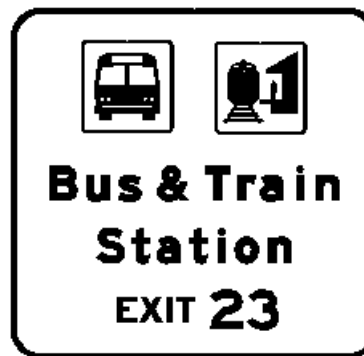
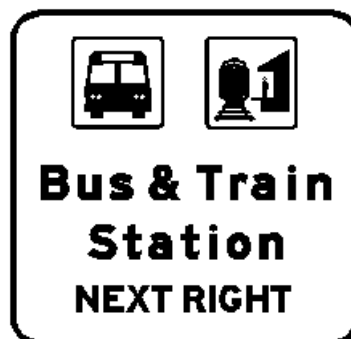
Figure I-A

Existing Sign on Mainline I-81 Northbound

Proposed Replacement Sign on Mainline I-81 Northbound

Proposed New Sign on Mainline I-81 Northbound At Three Lane Exit to Park St., Old Liverpool Rd. and Onondaga Lake Parkway

Figures I-A thru I-D show the existing signs along with proposed replacement signs using the legend “Bus & Train Station”. The proposed signs also incorporate the bus and train symbol plaques within the main panel.

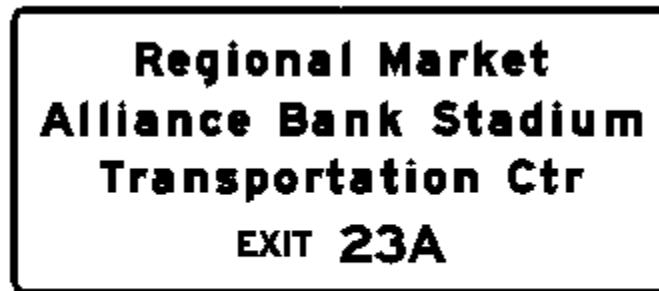
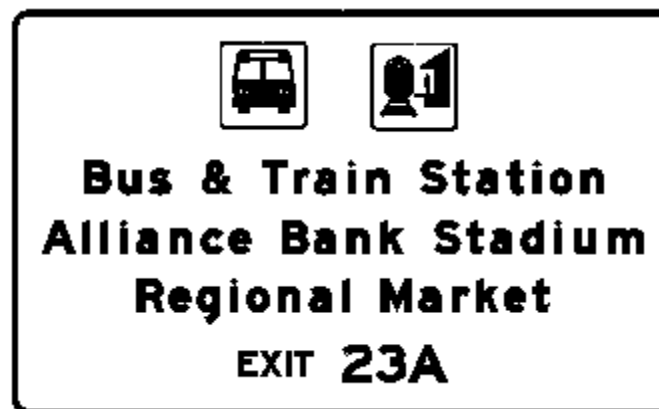
Figure I-B

Existing Sign on Mainline I-81 Southbound

Proposed Replacement Sign on Mainline I-81 Southbound

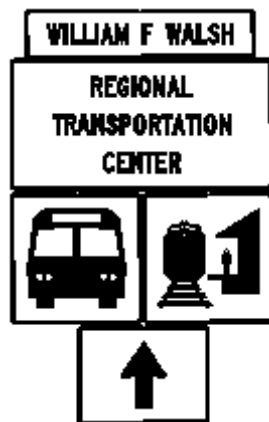
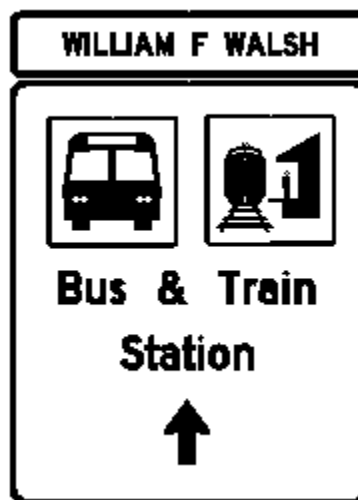
Figure I-D

Existing Sign at Various Intersections  
Along Park St, Hiawatha Blvd, and Bear St

Proposed Replacement Sign at Various Intersections  
Along Park St, Hiawatha Blvd, and Bear St
